Home Performance with ENERGY STAR® Evaluation Report

Date of Evaluation: November 12, 2007
Consultant Name: Name of Rater
Company Phone: 888-451-4092

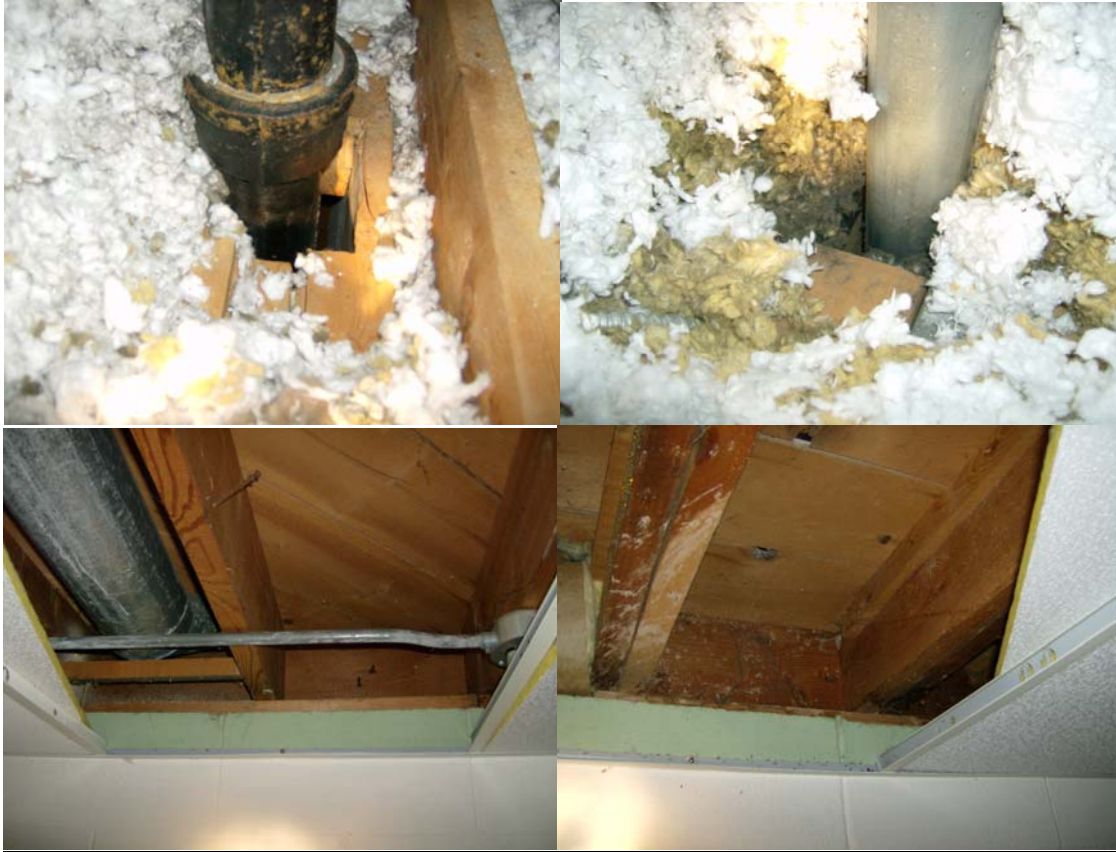
There are significant air leaks around plumbing penetrations from the basement to the attic. Sealing these will help reduce air infiltration into the home. There are significant air leaks around the box sill area and the top of the foundation Wall. Would recommend spray foaming box sill and top of the block foundation. Would also recommend spray foaming the floor overhang in the rear of the house. The windows are old single pain and are very leaky would recommend replacing them with new ENERGY STAR windows. For the short term fix, install new weather stripping on sashes to reduce air infiltration.

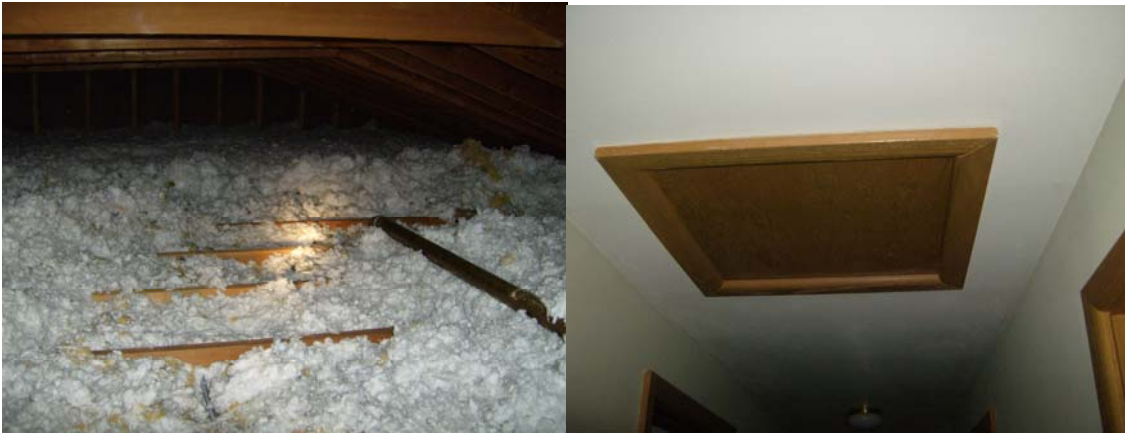
The exterior walls appear to have adequate insulation in them when viewed through an infrared camera. The attic insulation around the access openings needs to be re-blown, also recommend insulating and installing weather stripping around attic access door.

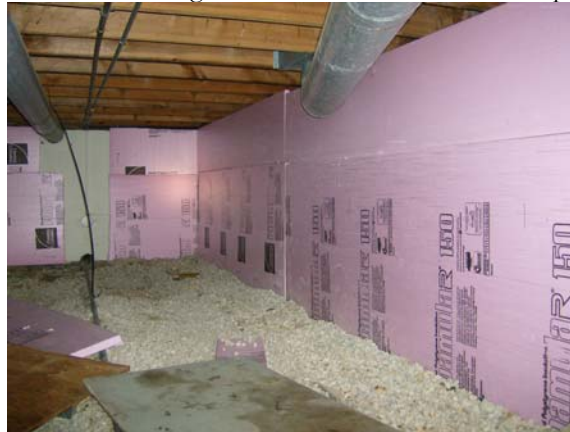
Crawl space walls have been partially insulated. Recommend installing missing foam insulation. Basement walls have no insulation. Adding interior wall insulation will help reduce heat loss.
